I installed the twin stick kit to eliminate any issue related to worn out stock 4WD shift linkage.

During my installation, I also fabricated a locking mechanism to lock the linkage in HI and LO lever in the neutral detent ball locations as a way to prevent the Orion from popping out of gear. I installed a pop pin on the HI/LO selector lever. The pop pin engages into an engagement plate attached to the top of the transmission. The engagement plate has a hole located to lock the lever at HI and LO.

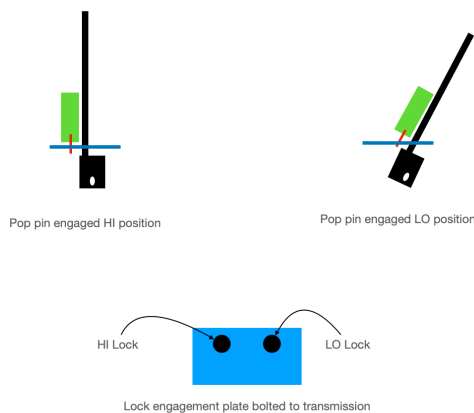
Figure 1.

After installing this locking mechanism, I never had any issues with popping out of HI. I did experience what felt like the Orion wanting to jump out of LO while on deceleration or going down and incline with the engine providing braking.

I hear an audible pop and at the same time feel the pop as a hard slip of the teeth. It's a momentary pop and not a series of multiple.

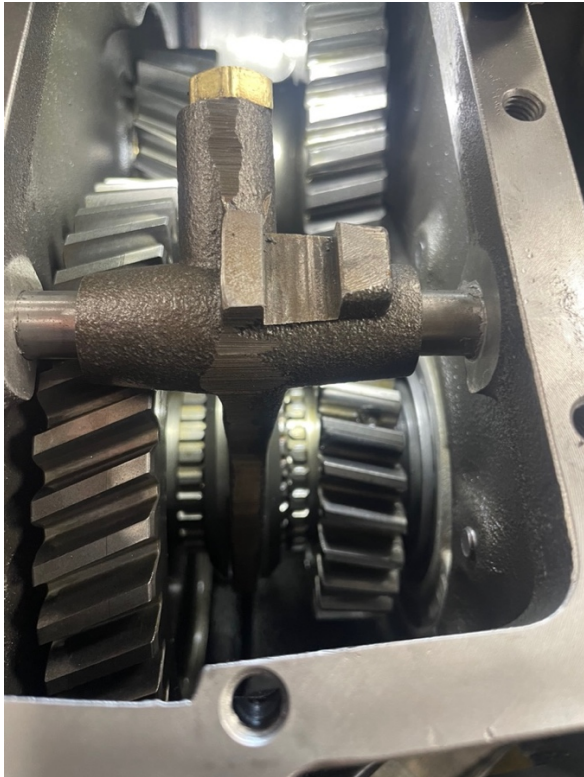
Figure 2 shows the shift fork and shift ring in neutral position in the center detent.

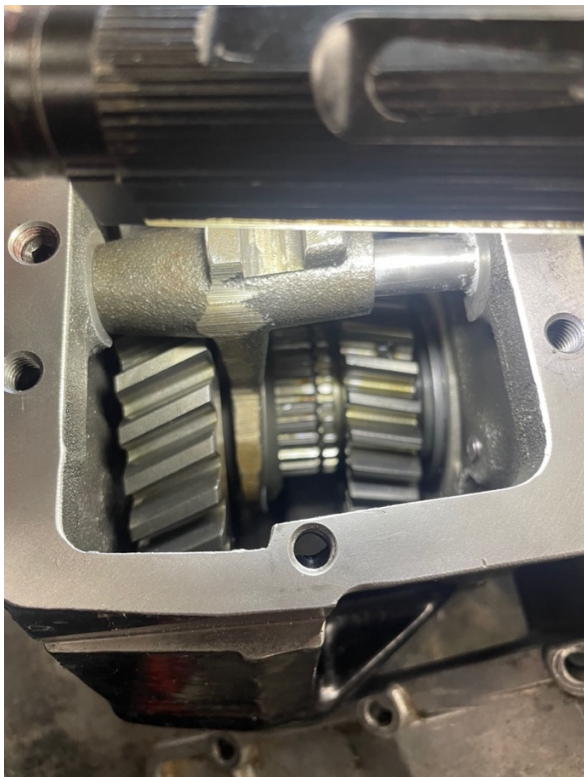
Figure 3 shows the position of the shift fork and slider ring when in LO gear.

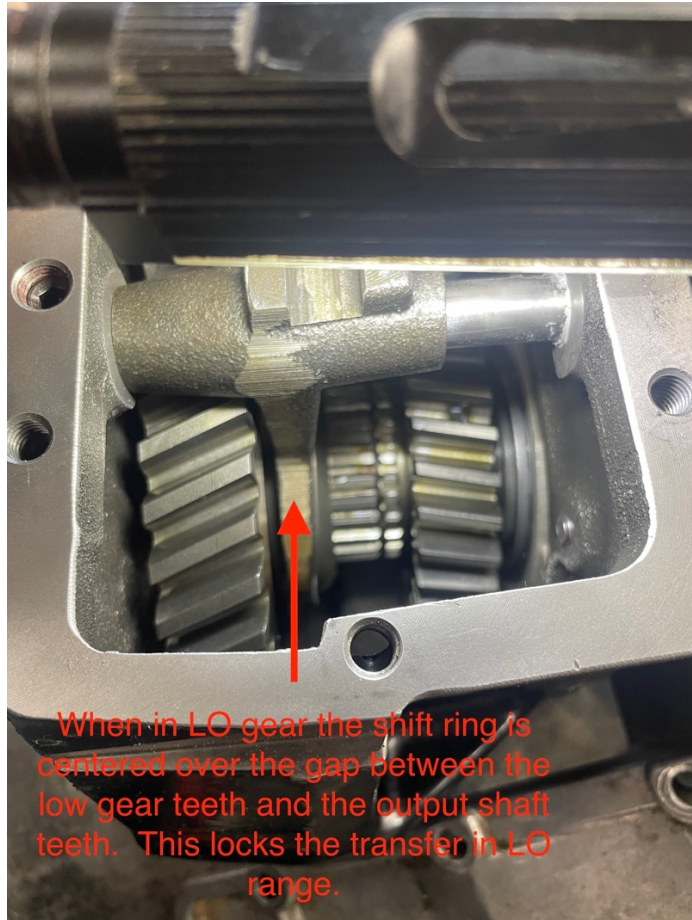
Figure 4 illustrates the shift ring is roughly centered over the gap between the output shaft and the low gear teeth. This appears as you would expect.

In this position, the shift ring should ride there unless some force acts on it to cause it to move toward the center (neutral). Only two possible forces exist... (1) force from the shift fork as transferred from the HI/LO shifter. In my case, since it's locked into place, there is no force acting on it to move toward neutral.

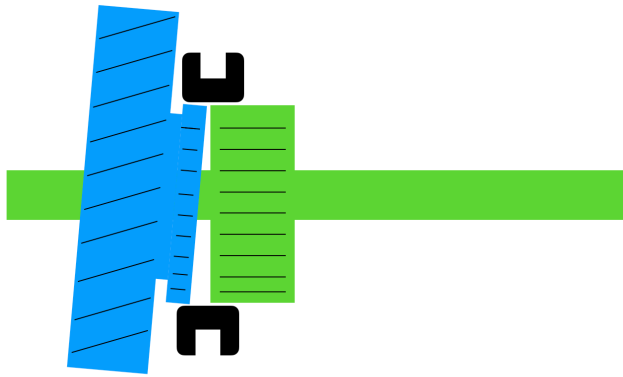
The second possible force comes from the low gear being able to wobble or sit canted on the output shaft which may cause the shift ring to move toward center. Figure 5 shows an exaggerated LO gear canted on the output shaft.

Is a slip/pop possible with the shift ring in the normal detent position and the LO gear is canted on the output shaft like Figure 5? I would think not. That depends on the tolerance between the Orion gear and the shift ring. With both being new, I wouldn't think this isn't an issue.

With firm hand pressure applied to the HI/LO lever, I don't get any popping? Does this mean that the pressure is keeping the gear from canting on the output shaft? If so, then the tolerance between the Orion gear bushing and the output shaft is too great. **We can test this theory with a new gear or a new bushing pressed into the gear I have.**

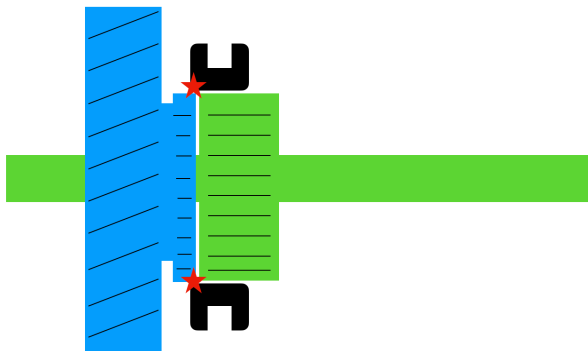
Figure 6

To experience a popping or slipping of the gears, this can only logically happen at the point where the shift ring is at the very edge of the LO gear. (see starred area on figure 6). In order for this to occur the shift ring has to travel almost $\frac{1}{2}$ inch. Movement of this much is impossible with my lever locked in position so how is this happening?

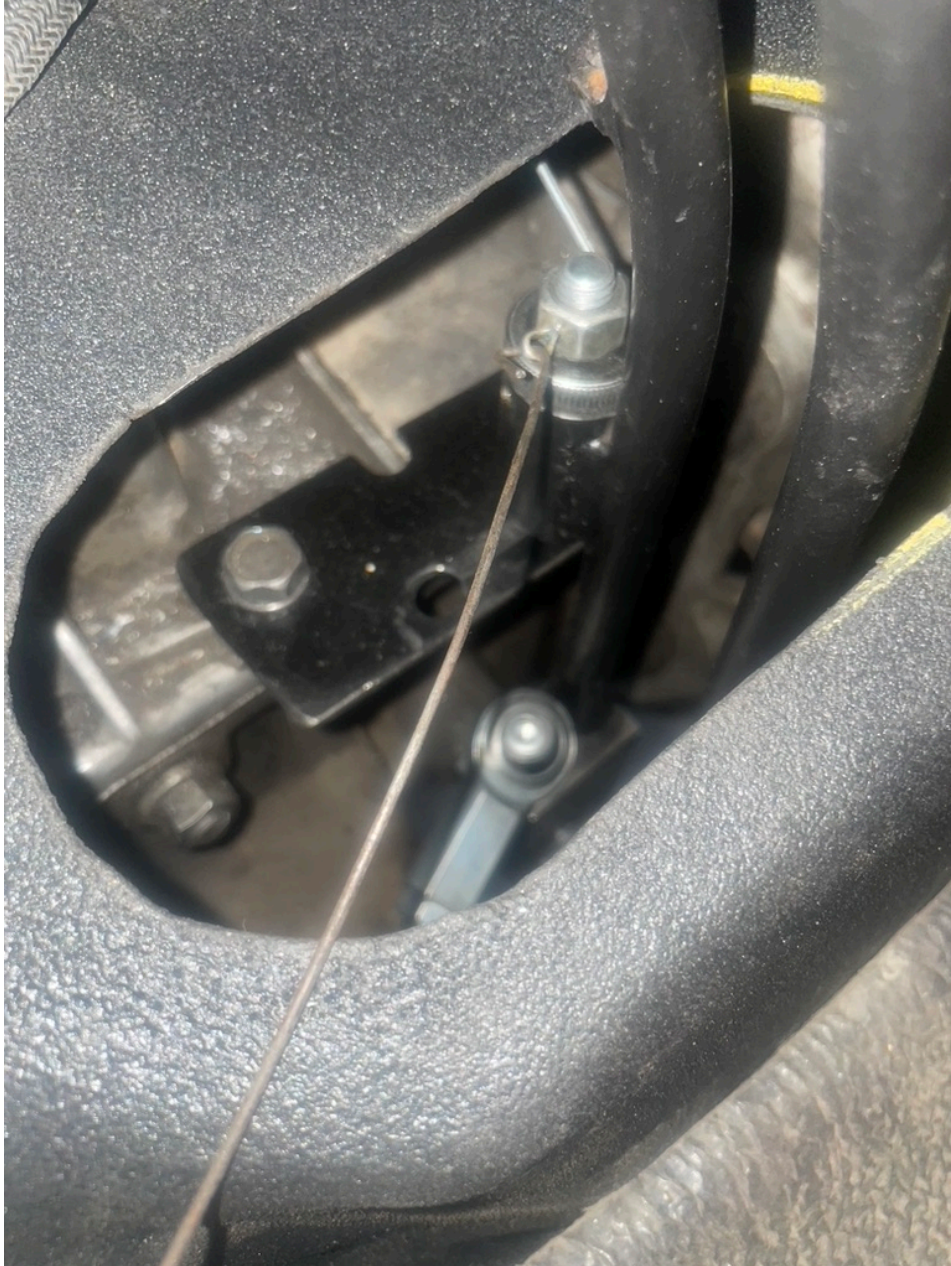
Figure 7

For reference, the following is a picture of my fabricated locking mechanism. I have a temporary wire attached to lift the pop pin. My plan is to have a more professional solution once I proved the concept.
