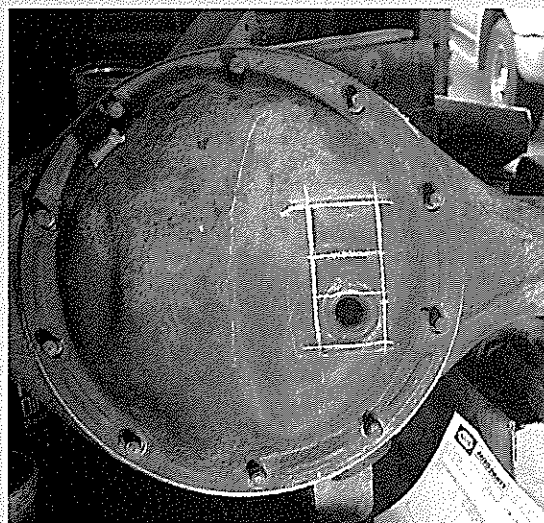
Locating the new filler hole.

While performing a spring over lift on my FJ40, I needed to point the rear pinion up towards the transfer case. This realignment solved several issues: reduced the u-joint operating angles; kept the pinion out of the rocks; and if performed in conjunction with a constant velocity joint at the transfer case, will reduce vibration. Unfortunately, pointing the pinion up also causes a problem—lack of oil. The low-buck solution to this problem is to overfill the axle to restore the oil to the bottom of the outer pinion bearing. To accomplish this, I marked the location where I wanted the filler hole to be and then made accompanying marks around the existing filler. After cutting out the rectangle formed, it is a simple process to rotate the piece and weld it back into the cover. Before welding, coat the plug threads with a thick coat of grease or a wet rag to keep them free of weld splatter. The new differential cover will allow you to raise the oil level without making a mess by simply trying to force in more oil.

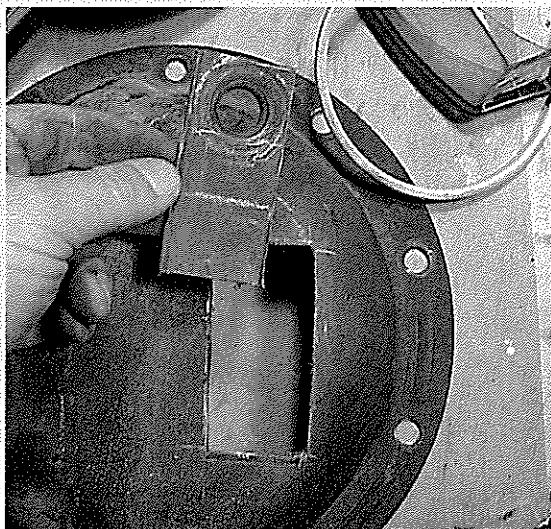
The cover cut and ready for welding.

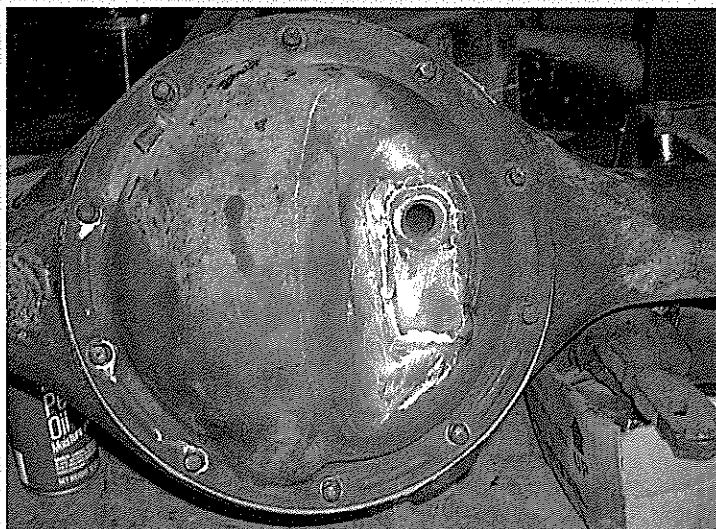
The newly positioned fill plug hole.
