Last Modified: 2-6-2018	6.8:8.0.48	Doc ID: RM000003XLR02EX
Model Year Start: 2015	Model: Land Cruiser	Prod Date Range: [08/2014 -]
Title: AUDIO / VIDEO: AUDIO AND VISUAL SYSTEM (w/ Navigation System): Display Signal Circuit between Multi-display and Radio Receiver; 2015 MY Land Cruiser [08/2014 -]

Display Signal Circuit between Multi-display and Radio Receiver

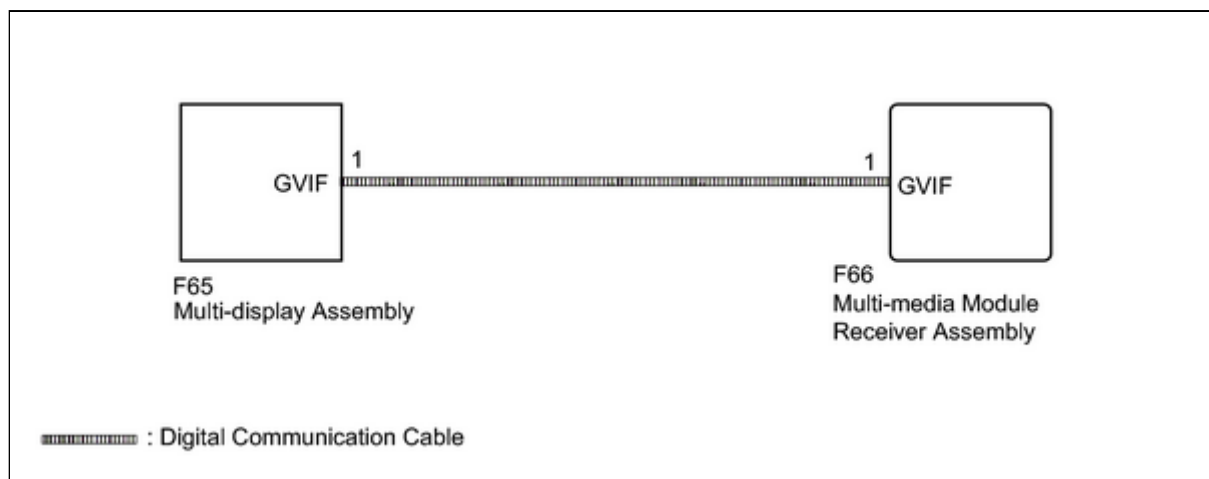
WIRING DIAGRAM

The display image signal from the multi-media module receiver assembly is sent to the multi-display assembly using a digital communication cable.
