2000 Toyota Land Cruiser

This vehicle is in good running and driving condition with a few things of note.

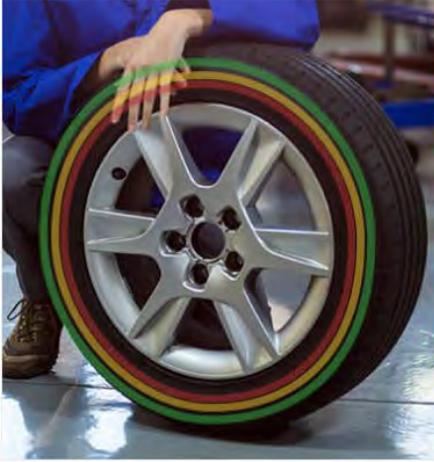
| 10/32 OR MORE |
| Tires have plenty of tread! (standard) |
| 8/32 OR MORE |
| Tires have plenty of tread! (low profile) |
| 5/32 TO 7/32 |
| Tires will need replacement soon! |
| 4/32 OR LESS |
| Tires need replacement! |

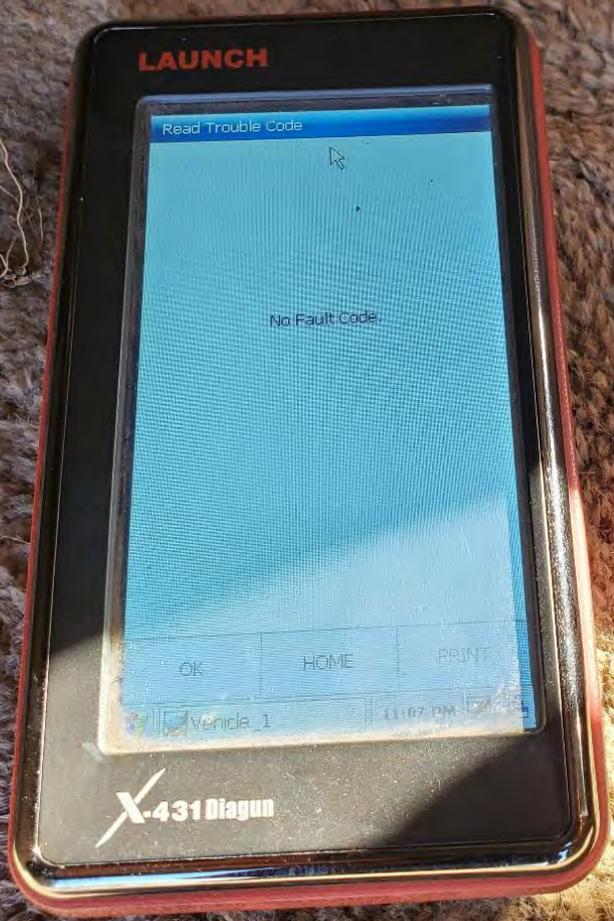
Read Trouble Code

No Fault Code
