## Toyota Truck Park Brake Bellcrank Repair

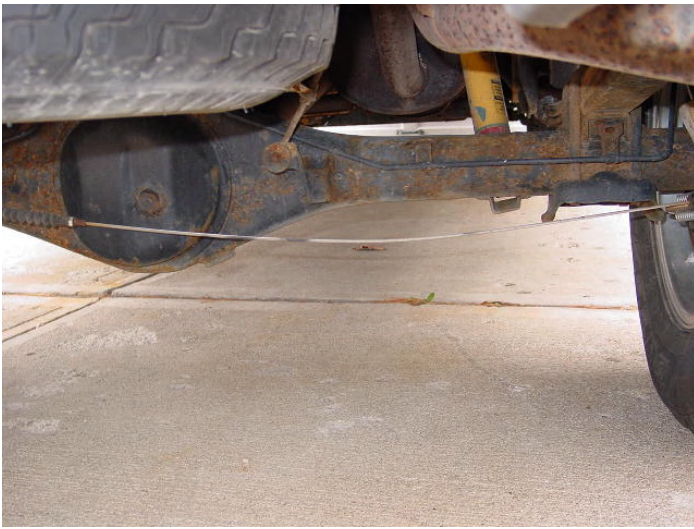
Toyota trucks including Tacoma, T100 and Tundra with rear drum brakes use a bellcrank apparatus through the brake backing plate as part of the parking brake system. These bellcranks, made of aluminum and steel are known for seizing up. The photo below (*fig. 1*) shows the tell tale sign of a seized bellcrank, this one being on the right side. The sagging cable that runs across the differential is a warning. If you notice this you need to check the action of the bellcranks before using the parking brake further. Using the parking brake with this condition can cause damage to the brake shoes and drum.

Fig. 1 Sagging park brake cable

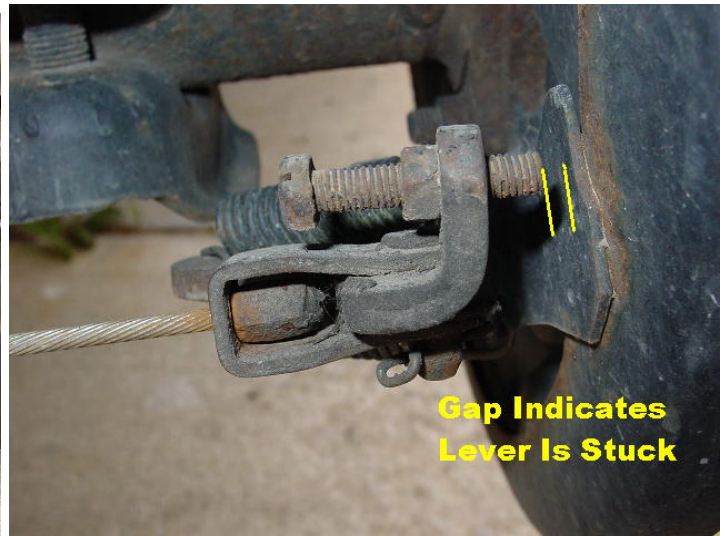
Fig. 2 Bellcrank stop off backing plate

A closer look at bellcrank stop (fig. 2) shows the bellcrank is not returning to its rest position. This and the sagging cable indicate a problem. Note, if you find the bellcrank not returning to stop as in figure 2 and see no sign of the cable sagging, this could indicate that the parking brake is either part way engaged or it is miss-adjusted. (See Park Brake and Rear Brake Shoe Adjustment starting on page 8) You can check the action of the bellcrank manually to verify the bellcrank is seized. It should move freely. Even if the cable is just too tight you should be able to pull the cable towards the side that is not against the backing plate, while pulling the other side off. If you find you can get no movement from the bellcrank, its time to pull the drums and get to work.

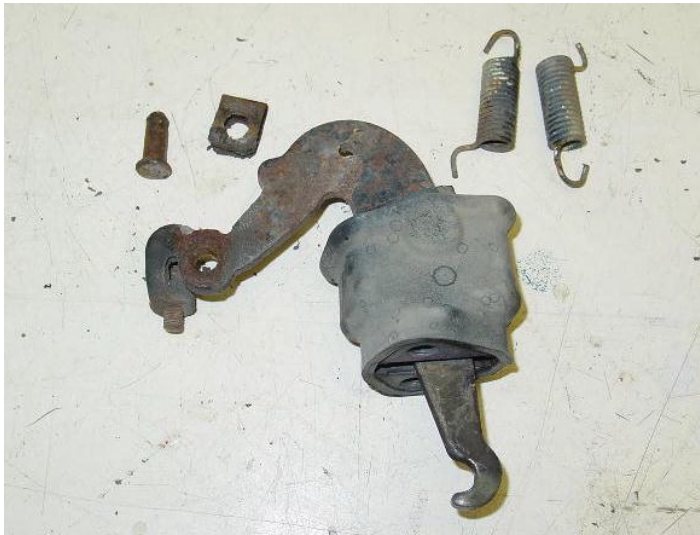
Fig. 7 Part to be serviced

You will now have the parts shown in figure 7 to clean and rebuild.

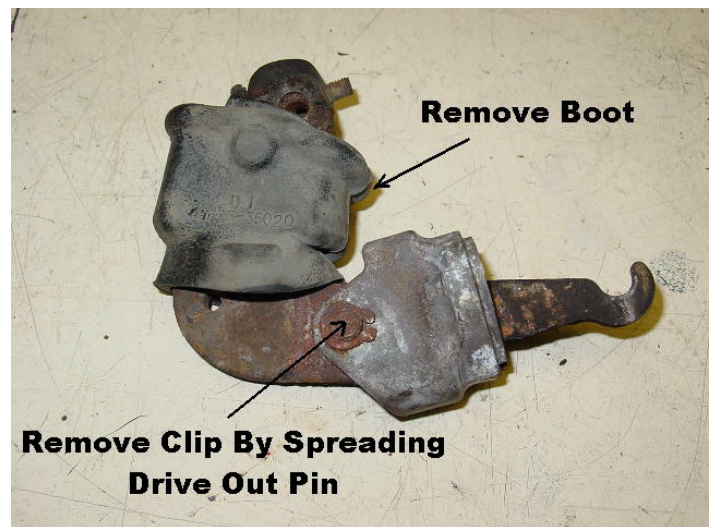
Fig. 8 Remove the boot

Begin by removing the rubber protective boot. Inspect the boot for damage, if none is found it can be cleaned up and reused. (fig.8)

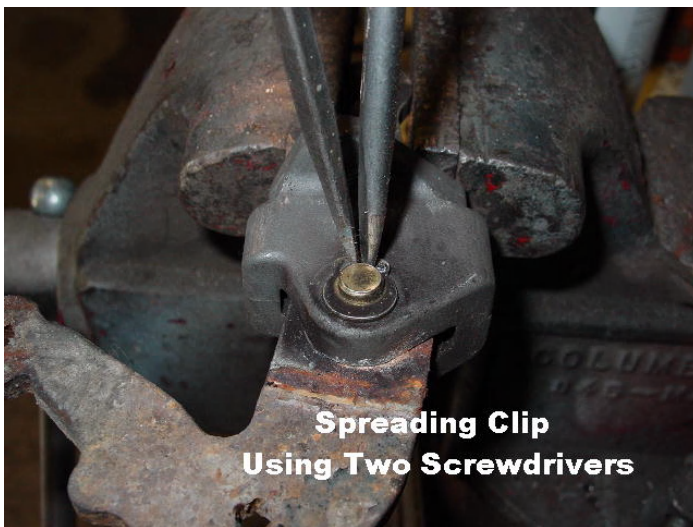
Fig. 9 Remove the U clip

Remove the U clip from the pivot pin. Use two screwdrivers to spread the clip. (Fig.9) If this clip is damaged replacements can be found at most auto parts stores.

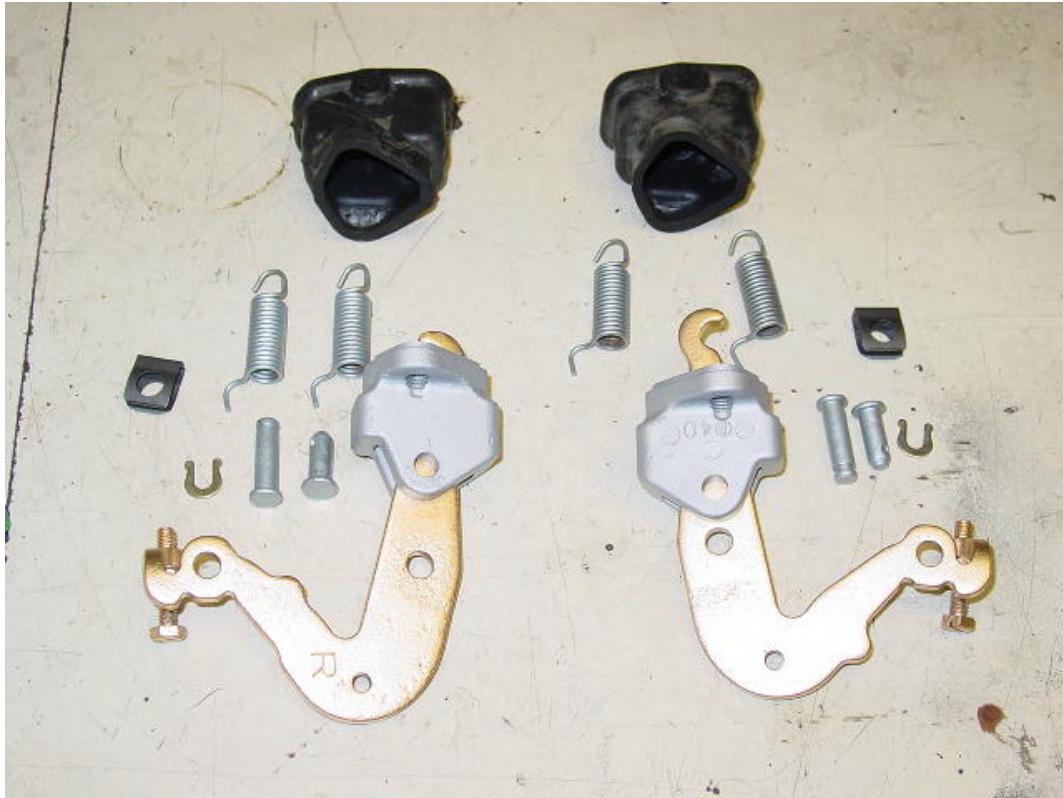
Fig. 11 All parts cleaned and painted

Figure 11 shows all the parts cleaned and repainted. Paints used here were Eastwood Aluma Blast #10109Z on the base, Eastwood Silver Cad #10022Z on the pins and springs, Rustoleum gold on the bellcrank arm. The rubber boots were cleaned using WD40.

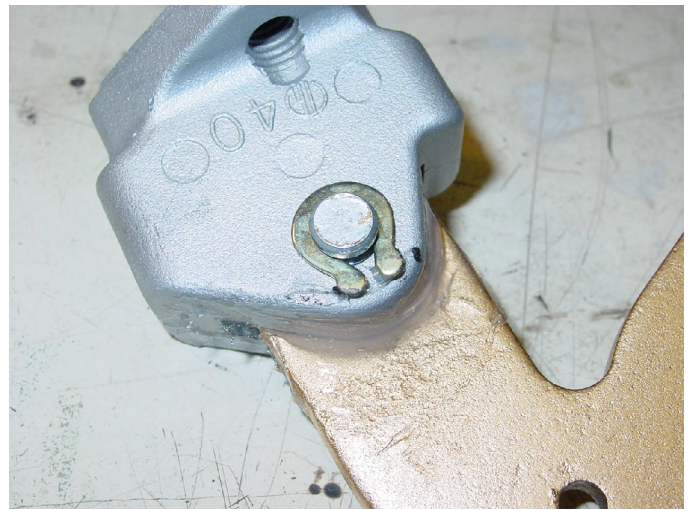
Fig. 13 Installing the lever and pin

Assemble the lever into the base, note the position of the base compared to the lever as shown in figure 12 and 13. Install the pivot pin and crimp the U clip using pliers. Pack more silicone grease around the opening in the base to prevent moisture entering. Slip the boot back into place.

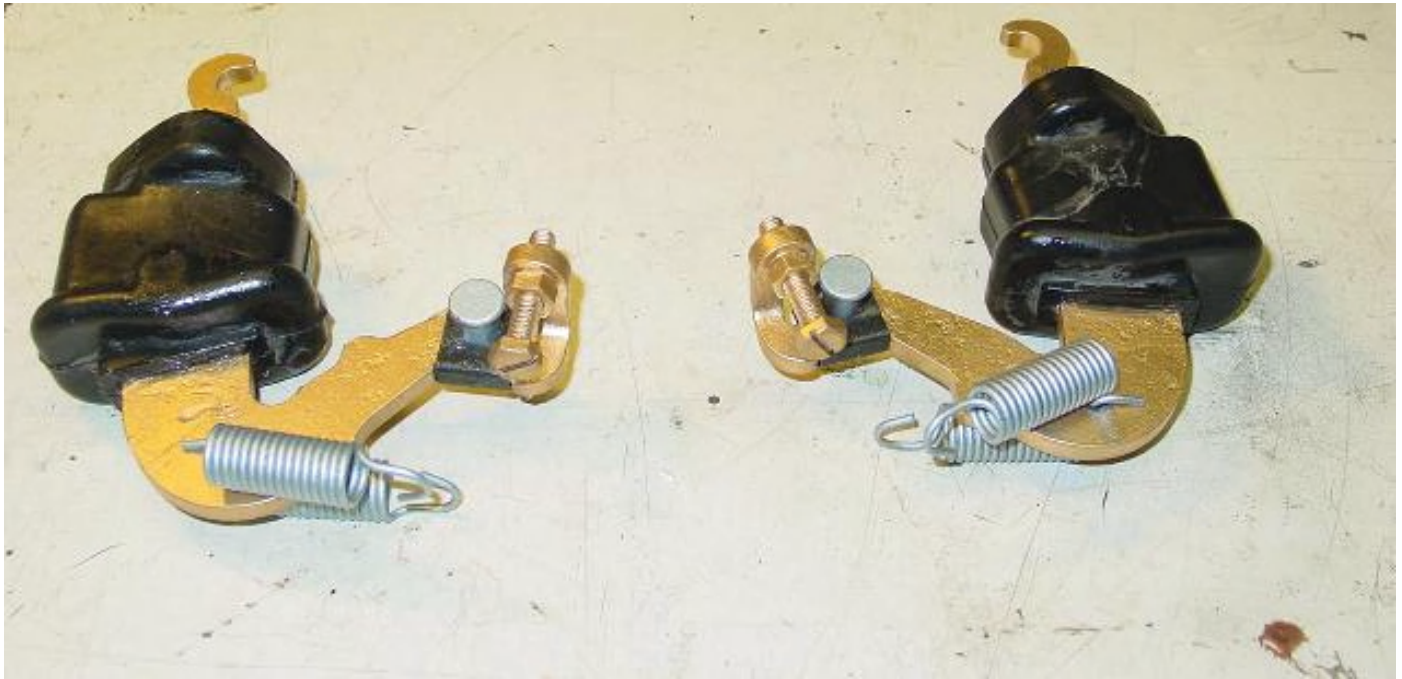
Fig. 15 Reconditioned bellcrank assemblies

Your brake bellcrank assemblies should look like the examples in figure 15 (next page). These are now ready to be reinstalled.

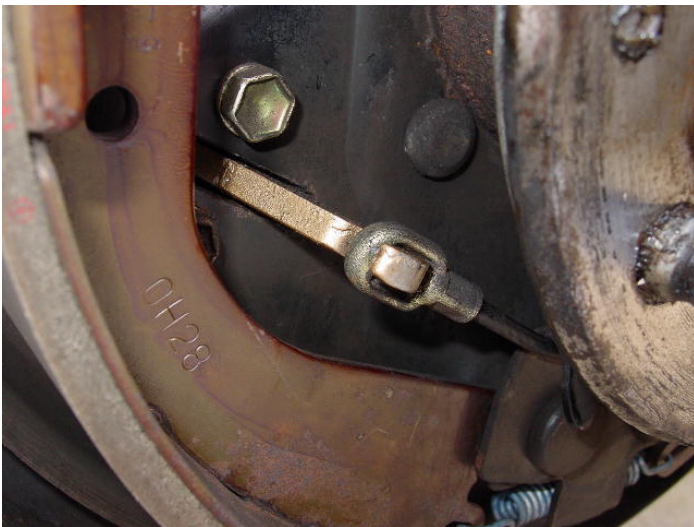
Fig. 16 Transfer cable must be attached

At the brake side, make sure the transfer cable is properly attached to the bellcrank lever and the cable is tucked under the cable guide as shown in figure 16 and 17.

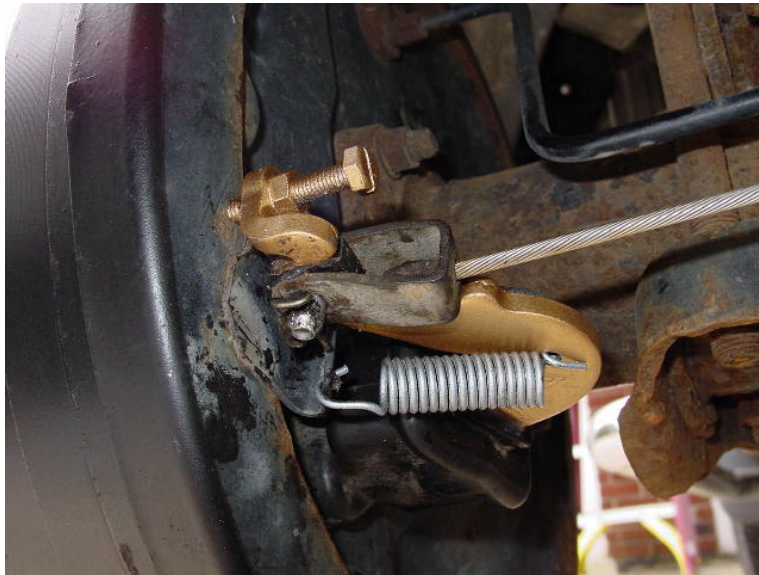
Fig. 18 Backside bellcrank installed

On the backside install the two springs, then the cable, spring clip and pin with hairpin. (fig. 18) At this time if the stop screws on the levers come completely back against the backing plates No adjusting is need to the park brake, but if it is not, or the stop screws were removed, you will need to readjust the park brake cable from scratch.
