## Replacing a Side Cover Gasket

My 1989 FJ62 has 254,000 miles, which is plenty for various gaskets to have failed once or twice. This truck has the 3F-E engine, a far-removed descendent of the 1950s-era straight 6 engines upon which it is based. After replacing the oil pan gasket, I still had a slight leak at the lower right side of the engine. The dreaded side cover gasket was oozing. The side cover is the steel plate that covers the valve lifter galley, extending the entire length of the engine. Murphy's Law says that this won't be an easy gasket to replace (although easier than the rear main seal, at least).

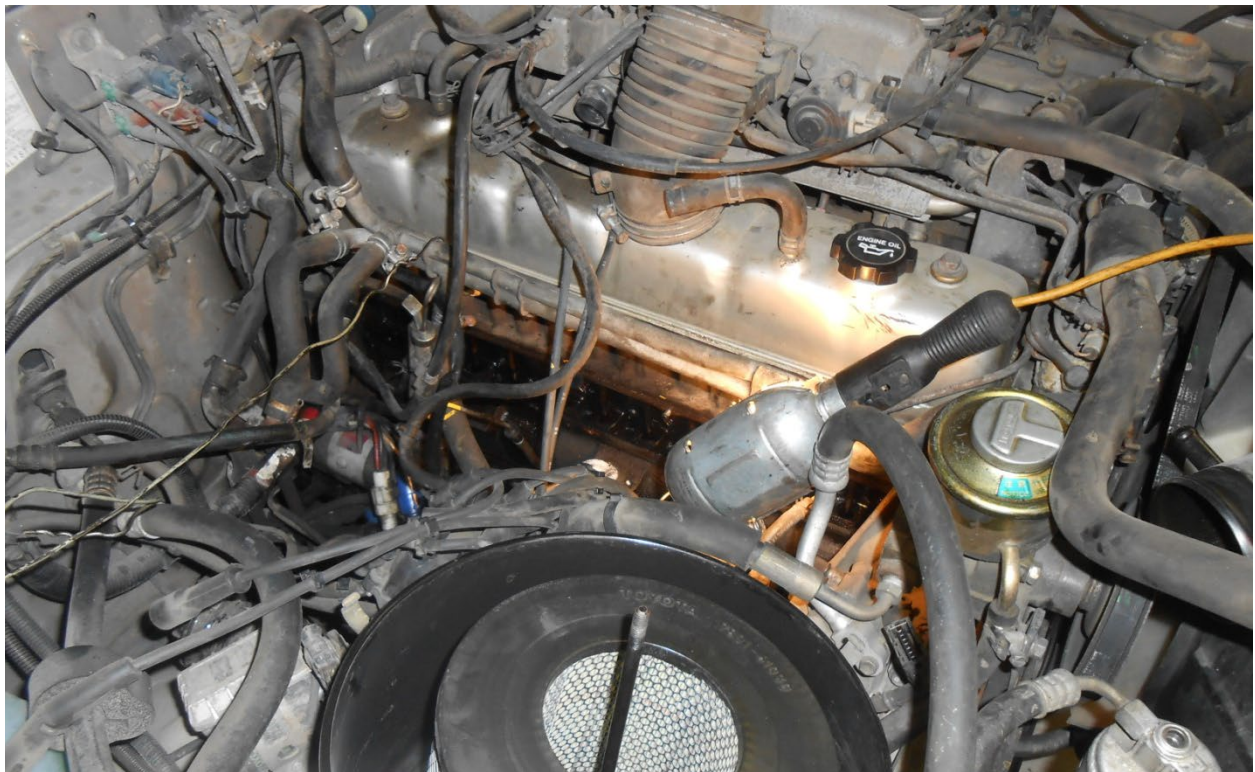
To remove the side cover itself, you have to get it out of the engine compartment – no small feat. On this truck, the side cover is trapped on the rear by the firewall, on the front by the A/C compressor bracket, and on the outside by the distributor, oil filter, and cooling system hard lines. It's 1930s technology trapped by 50 years of vehicle improvements and changes. It's probably a snap to change on an FJ25...but this is an FJ62.

**The area in which you'll be working to fix this leak**

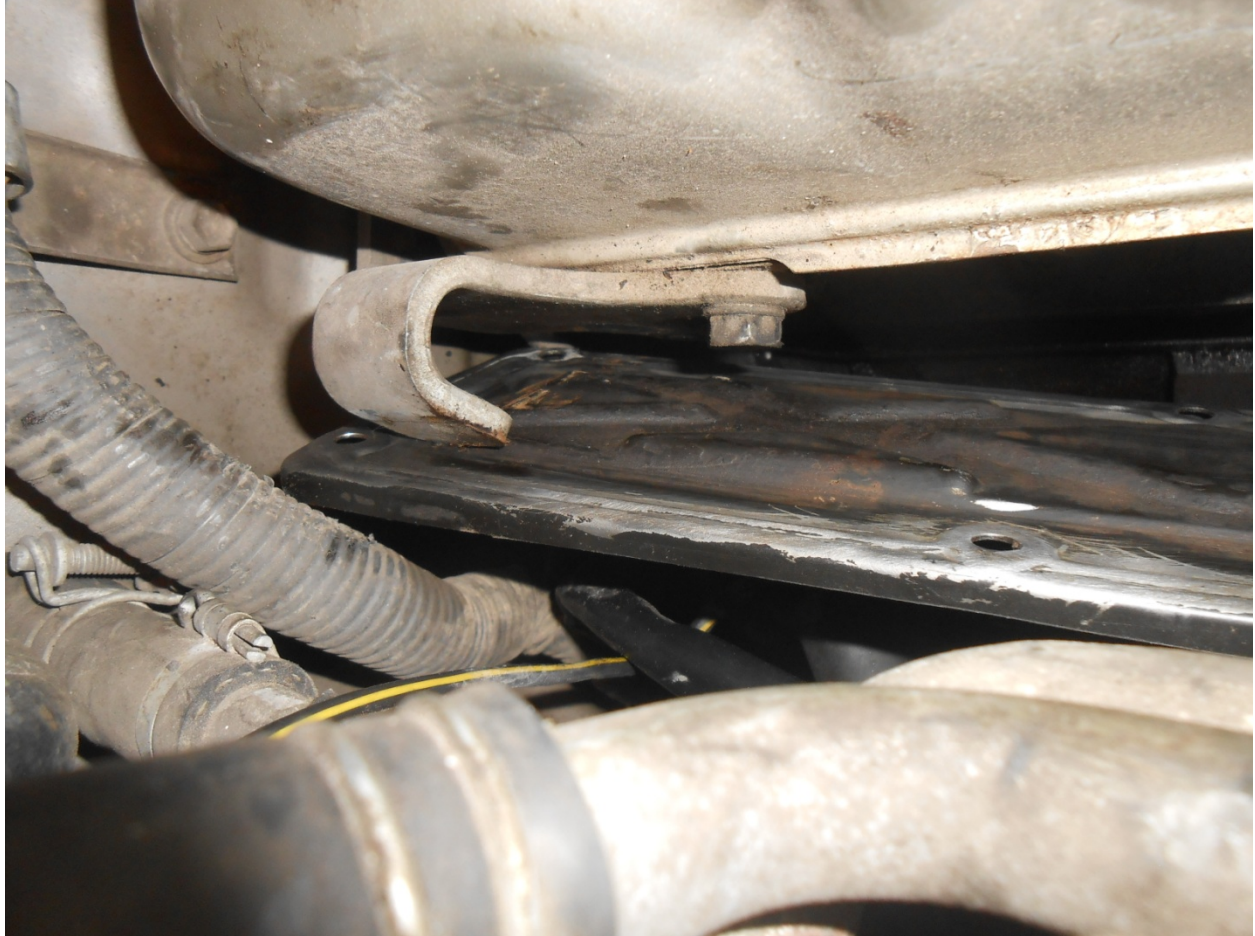
Here's where the fun begins. You will find that the side cover, when slid back to the firewall, won't clear the A/C bracket. When slid forward, it won't clear the engine hook, fuel line, or cooling system lines. At this point, you take a break and put on your thinking cap. After much study, I decided to flex the cover out past the engine hook, and around the fuel line, and slide the back edge up toward the valve cover.

**Sneaking the cover past the rear engine hook**

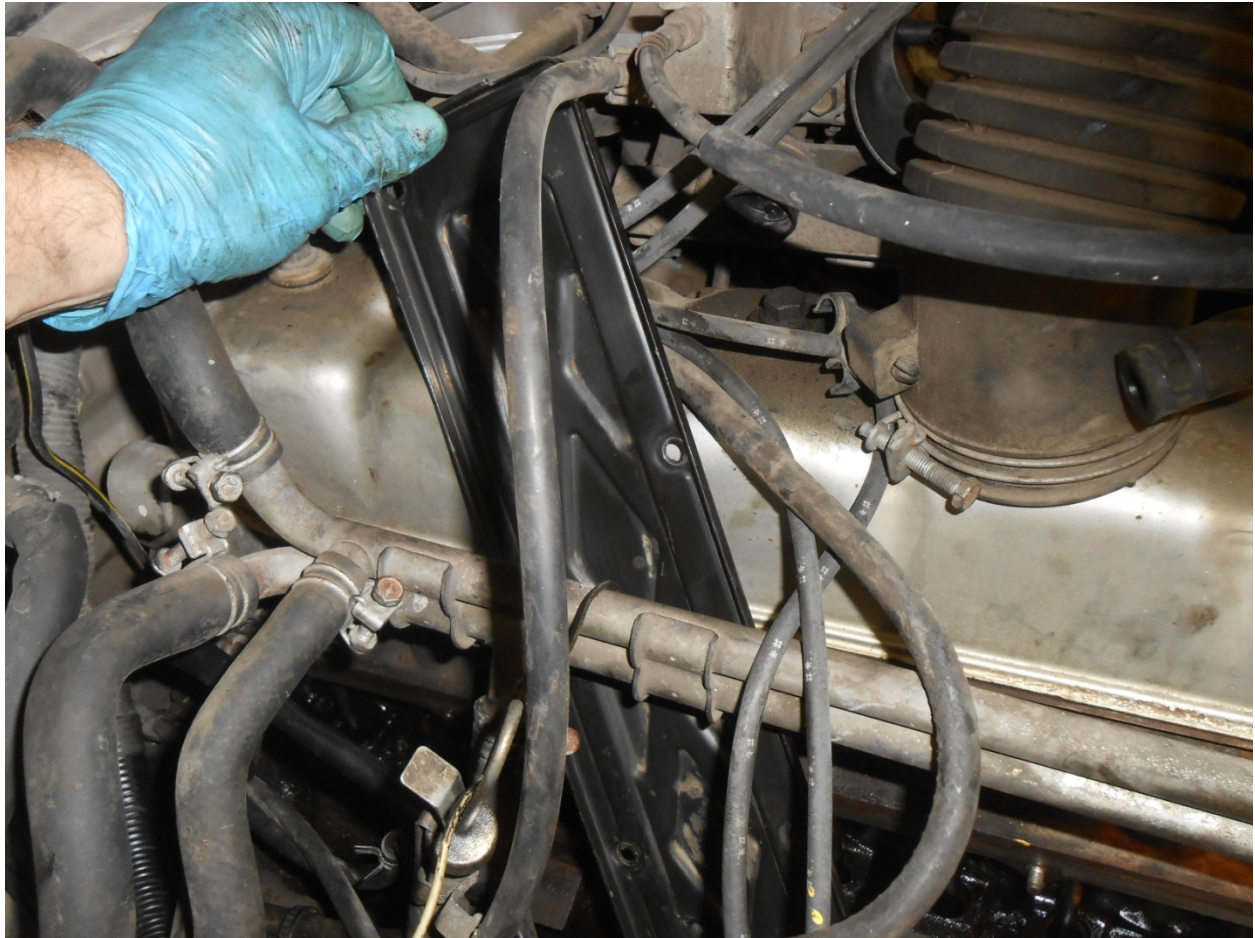
It is still trapped behind the cooling system lines and the hood. When you have gotten the cover high enough, you can tilt the cover, and get it to start falling down at the front of the engine.

**Pulling the cover up through the engine compartment *inside* the cooling system lines before lowering the cover through the suspension to the floor to clear those same cooling lines**

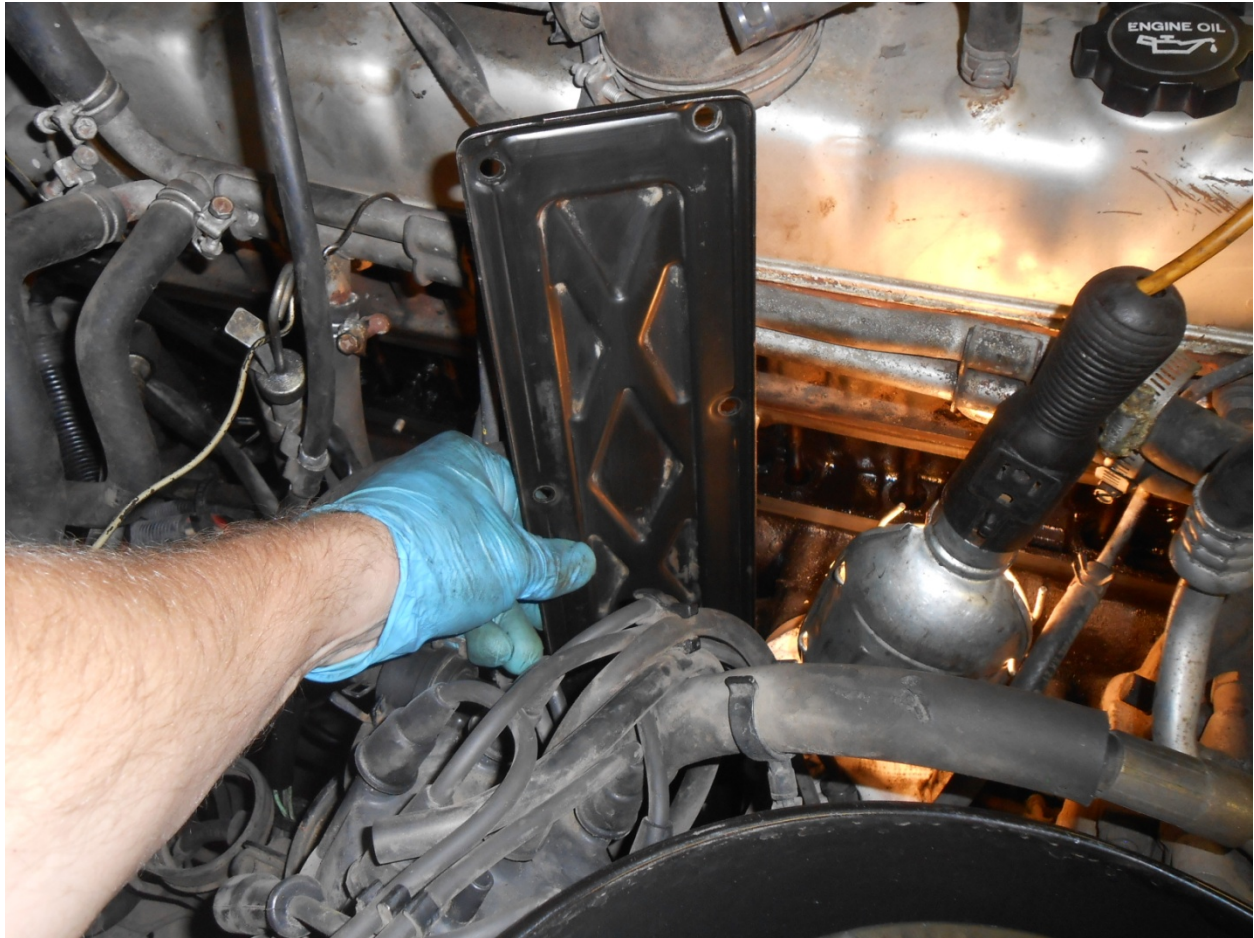
Eventually, I was able to drop the front end of the cover down below the engine toward the front axle, and get the cover vertical. At this point I could lift it up and out of the engine compartment. I did not distort or bend the cover during this removal process, but it grazes many surfaces as you slide it out.

**Pulling the cover up through the engine compartment *outside* the cooling system lines, which is key to removing the cover from the truck**

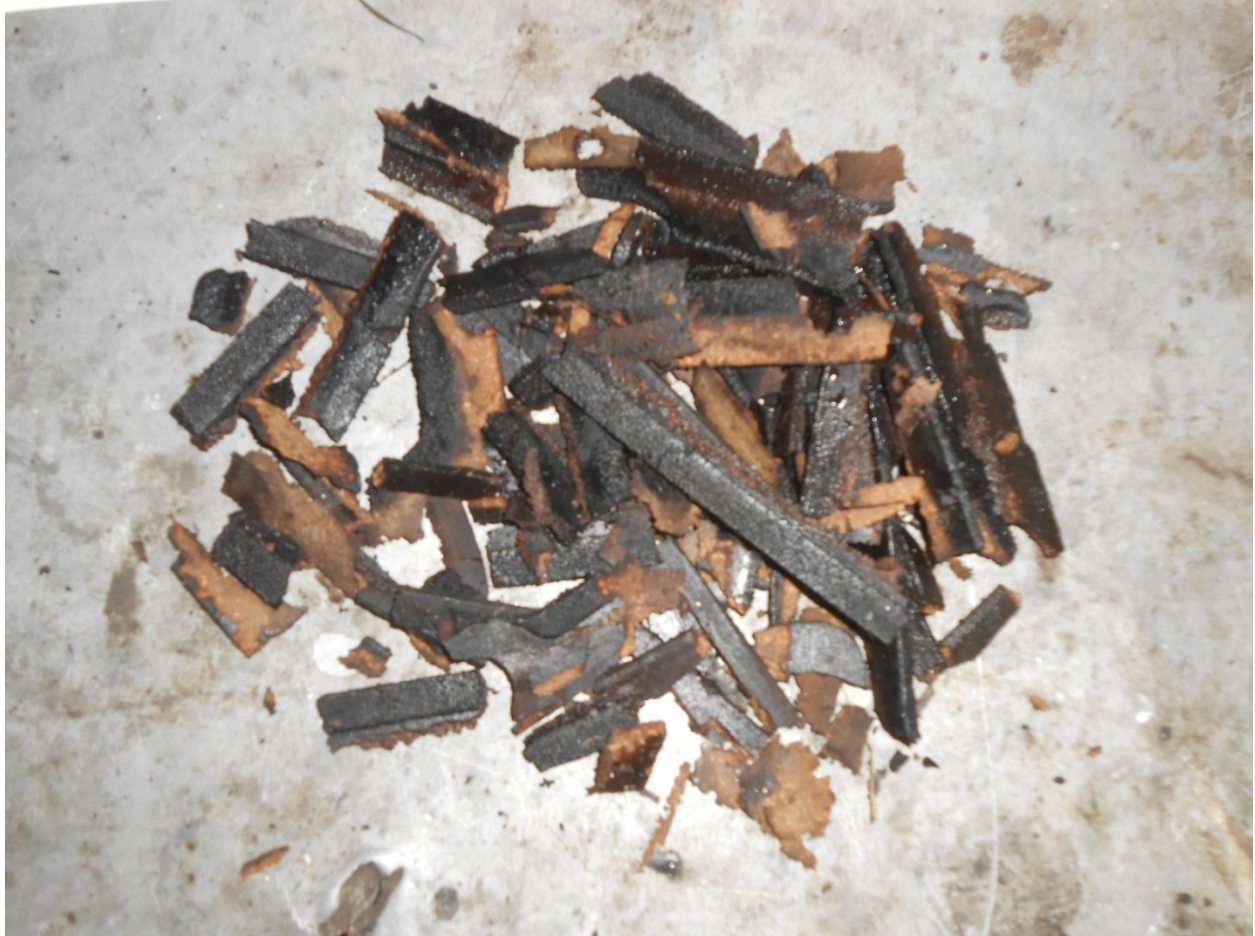
**The old gasket lacked a certain pliability!**

With the side cover out, I used a stiff putty knife and remove much of the crispy gasket from the cover. I then put a Scotchbrite pad on my die grinder, and spent a solid hour removing the baked-on gasket bits. Finally, the gasket face was clean. I used brake cleaner to clean the face of the cover, and then with a hammer, tapped each bolt hole flat to improving sealing. These holes are typically distorted from the bolts being over-tightened.

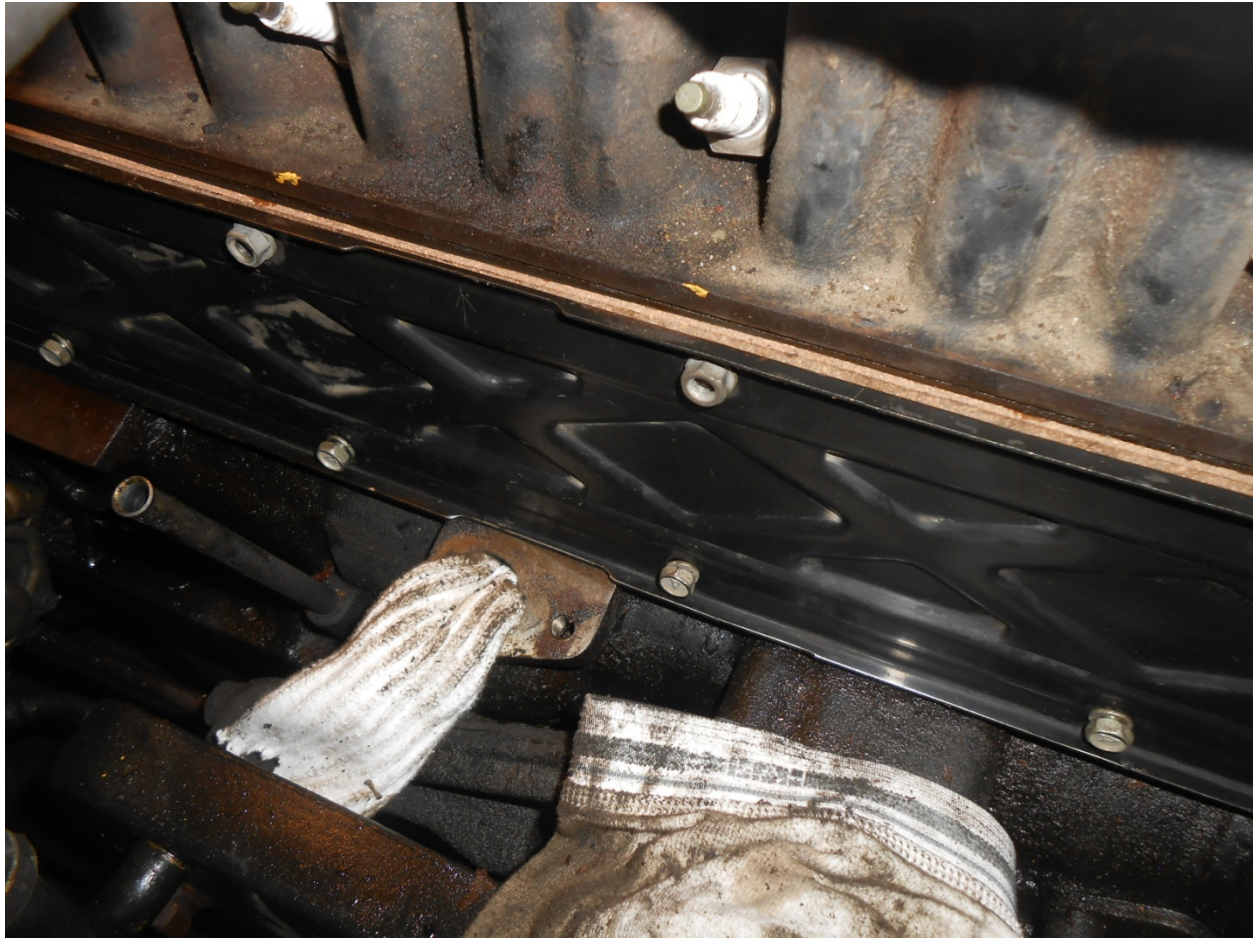
Bringing the cover back to the engine is the reverse of removal. When I had the cover adjacent to the block, I hung the new gasket on my four studs. The gasket sagged at the bottom, but this can be fixed later. I set the cover on front of the engine, hung it on the studs, and then aligned the gasket behind the cover. You have to fiddle with the gasket and holes and use an ice pick to coax the gasket holes to line up with the cover.

**Cover reinstalled with a new gasket and bolts/nuts loosely installed**

Finally, I removed my two studs, and installed all the factory bolts, and tightened them to 34 inch-pounds (not lb-ft).
