Exterior Rear View Mirror Vibration

Service
Category Vehicle Exterior

YEAR(S)	MODEL(S)	ADDITIONAL INFORMATION
2008 – 2011	Land Cruiser

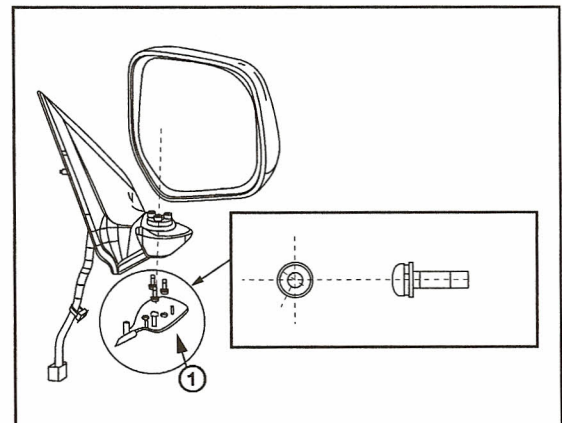
1 Lower Base Cover

Some Land Cruiser vehicles may exhibit a condition where the exterior rear view mirror vibrates while driving. A bolt set has been developed to change this condition.

1. Using a plastic pry tool, remove the lower base cover from the mirror housing assembly.
2. Remove and replace the 3 torx bolts with the new bolt set. **Figure 1.**

Torque: 3.7 N*m (37.7 kgf*cm, 33 in*lbf)

3. Replace lower base cover with new one provided in bolt set.
4. Road test vehicle to confirm proper operation of mirror assembly.
